# MULTIDISCIPLINAR APROACH TO HISTORICAL ARCH BRIDGES DOCUMENTATION

**KEY WORDS:** Historical Bridges, Close Range Photogrammetry, Laser Scanning, Ground Penetrating Radar.

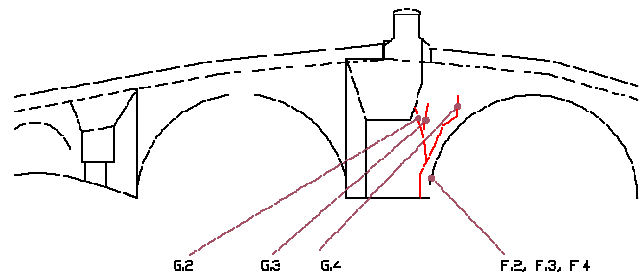
Figure 1. Front view of structural damages mapping in the Carracedo Bridge

The structural damages and the presence of degrading elements are collected in tables, plans and photographs. Tabs and photographs are linked in order to identify the pathologies as well as possible, in location and shape. (Figure 1; Figure 2.)

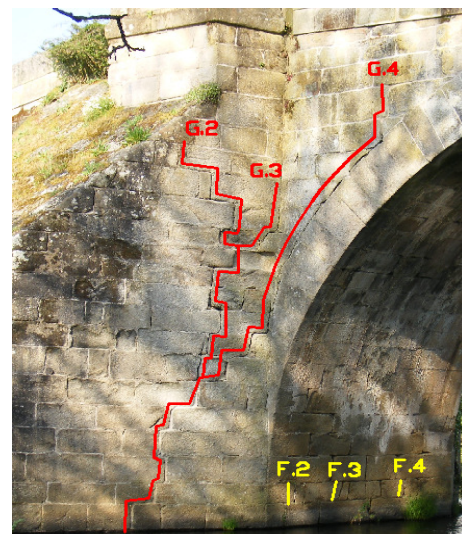
Figure 2. Cracks in the Carracedo Bridge.

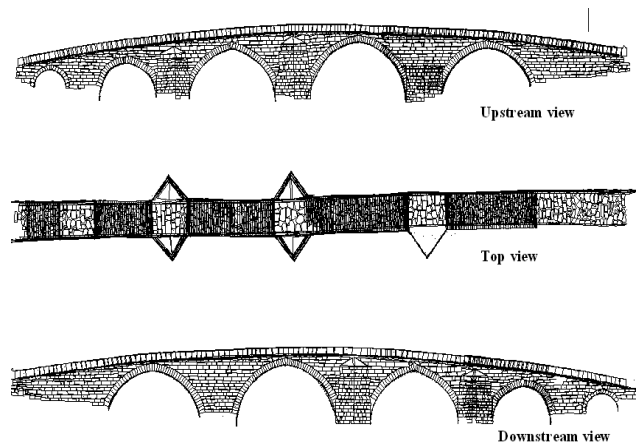
Figure 4. Wire frame of Cernadela Bridge.

Finally wire frame models were built (Figure 4), where also damages were identified (cracks, lack of materials, etc.) (Figure 5) and their dimensions. Solid models were created in order to use them in structural analysis, and to make photorealistic texturing.

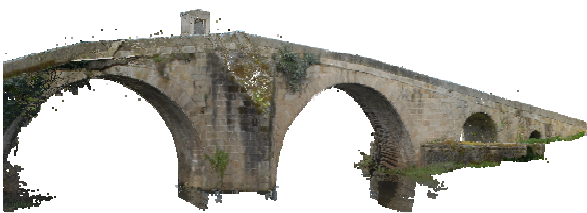
Figure 6. Coloured point cloud of Carracedo Bridge.

After the registry, the point clouds were filtered in order to obtain point clouds with a regular density of points. Also, the 3D points were colored from RGB information of the images taken with the camera (figure 6).

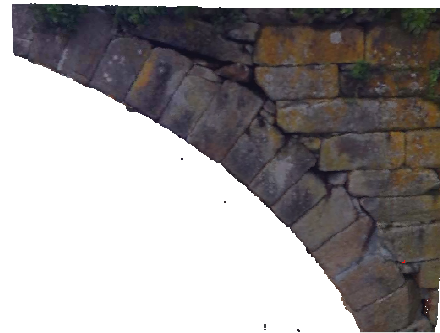
Figure 8. Coloured scan of a crack in an arch ring of Traba Bridge.

One of the purposes of this project is to obtain an accurate documentation of damages. In order to carry out multitemporal analyses of structural problems, all the damages observed were scanned accurately. An example is the crack observed between an arch ring and the ashlars of the wall of the Traba Bridge, which was scanned with a precision of 1mm.

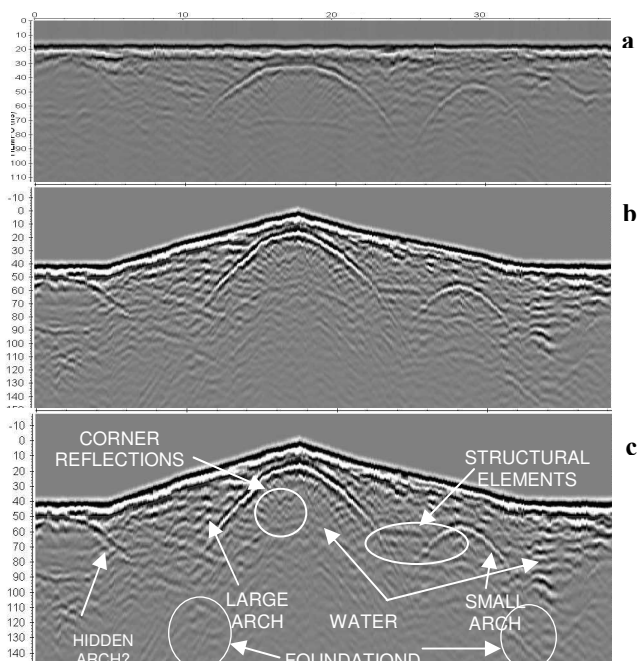
Figure 8. Data obtained with a GPR 200 MHz unshielded antenna: a) Raw data, b) After a basic processing sequence. c) Interpretation. Horizontal axis: Distance (m), vertical axis: Time (ns).

The figure clearly shows the arches and foundations of the bridge, as well as other structural elements and significant characteristics of the filling material.

Figure (8) shows an example of the radargrams obtained with a 200 MHz unshielded antenna in an ancient medieval bridge in Ceredo (Galicia).
